THE
GREAT EARTHQUAKE
OF JAPAN

1891.

BY
JOHN MILNE.
AND
W.K. BURTON.
PLATES BY K. OGAWA.

JOHN MILNE, F.R.S. PROFESSOR OF MINING AND GEOLOGY ; IMPERIAL UNIVERSITY OF JAPAN,

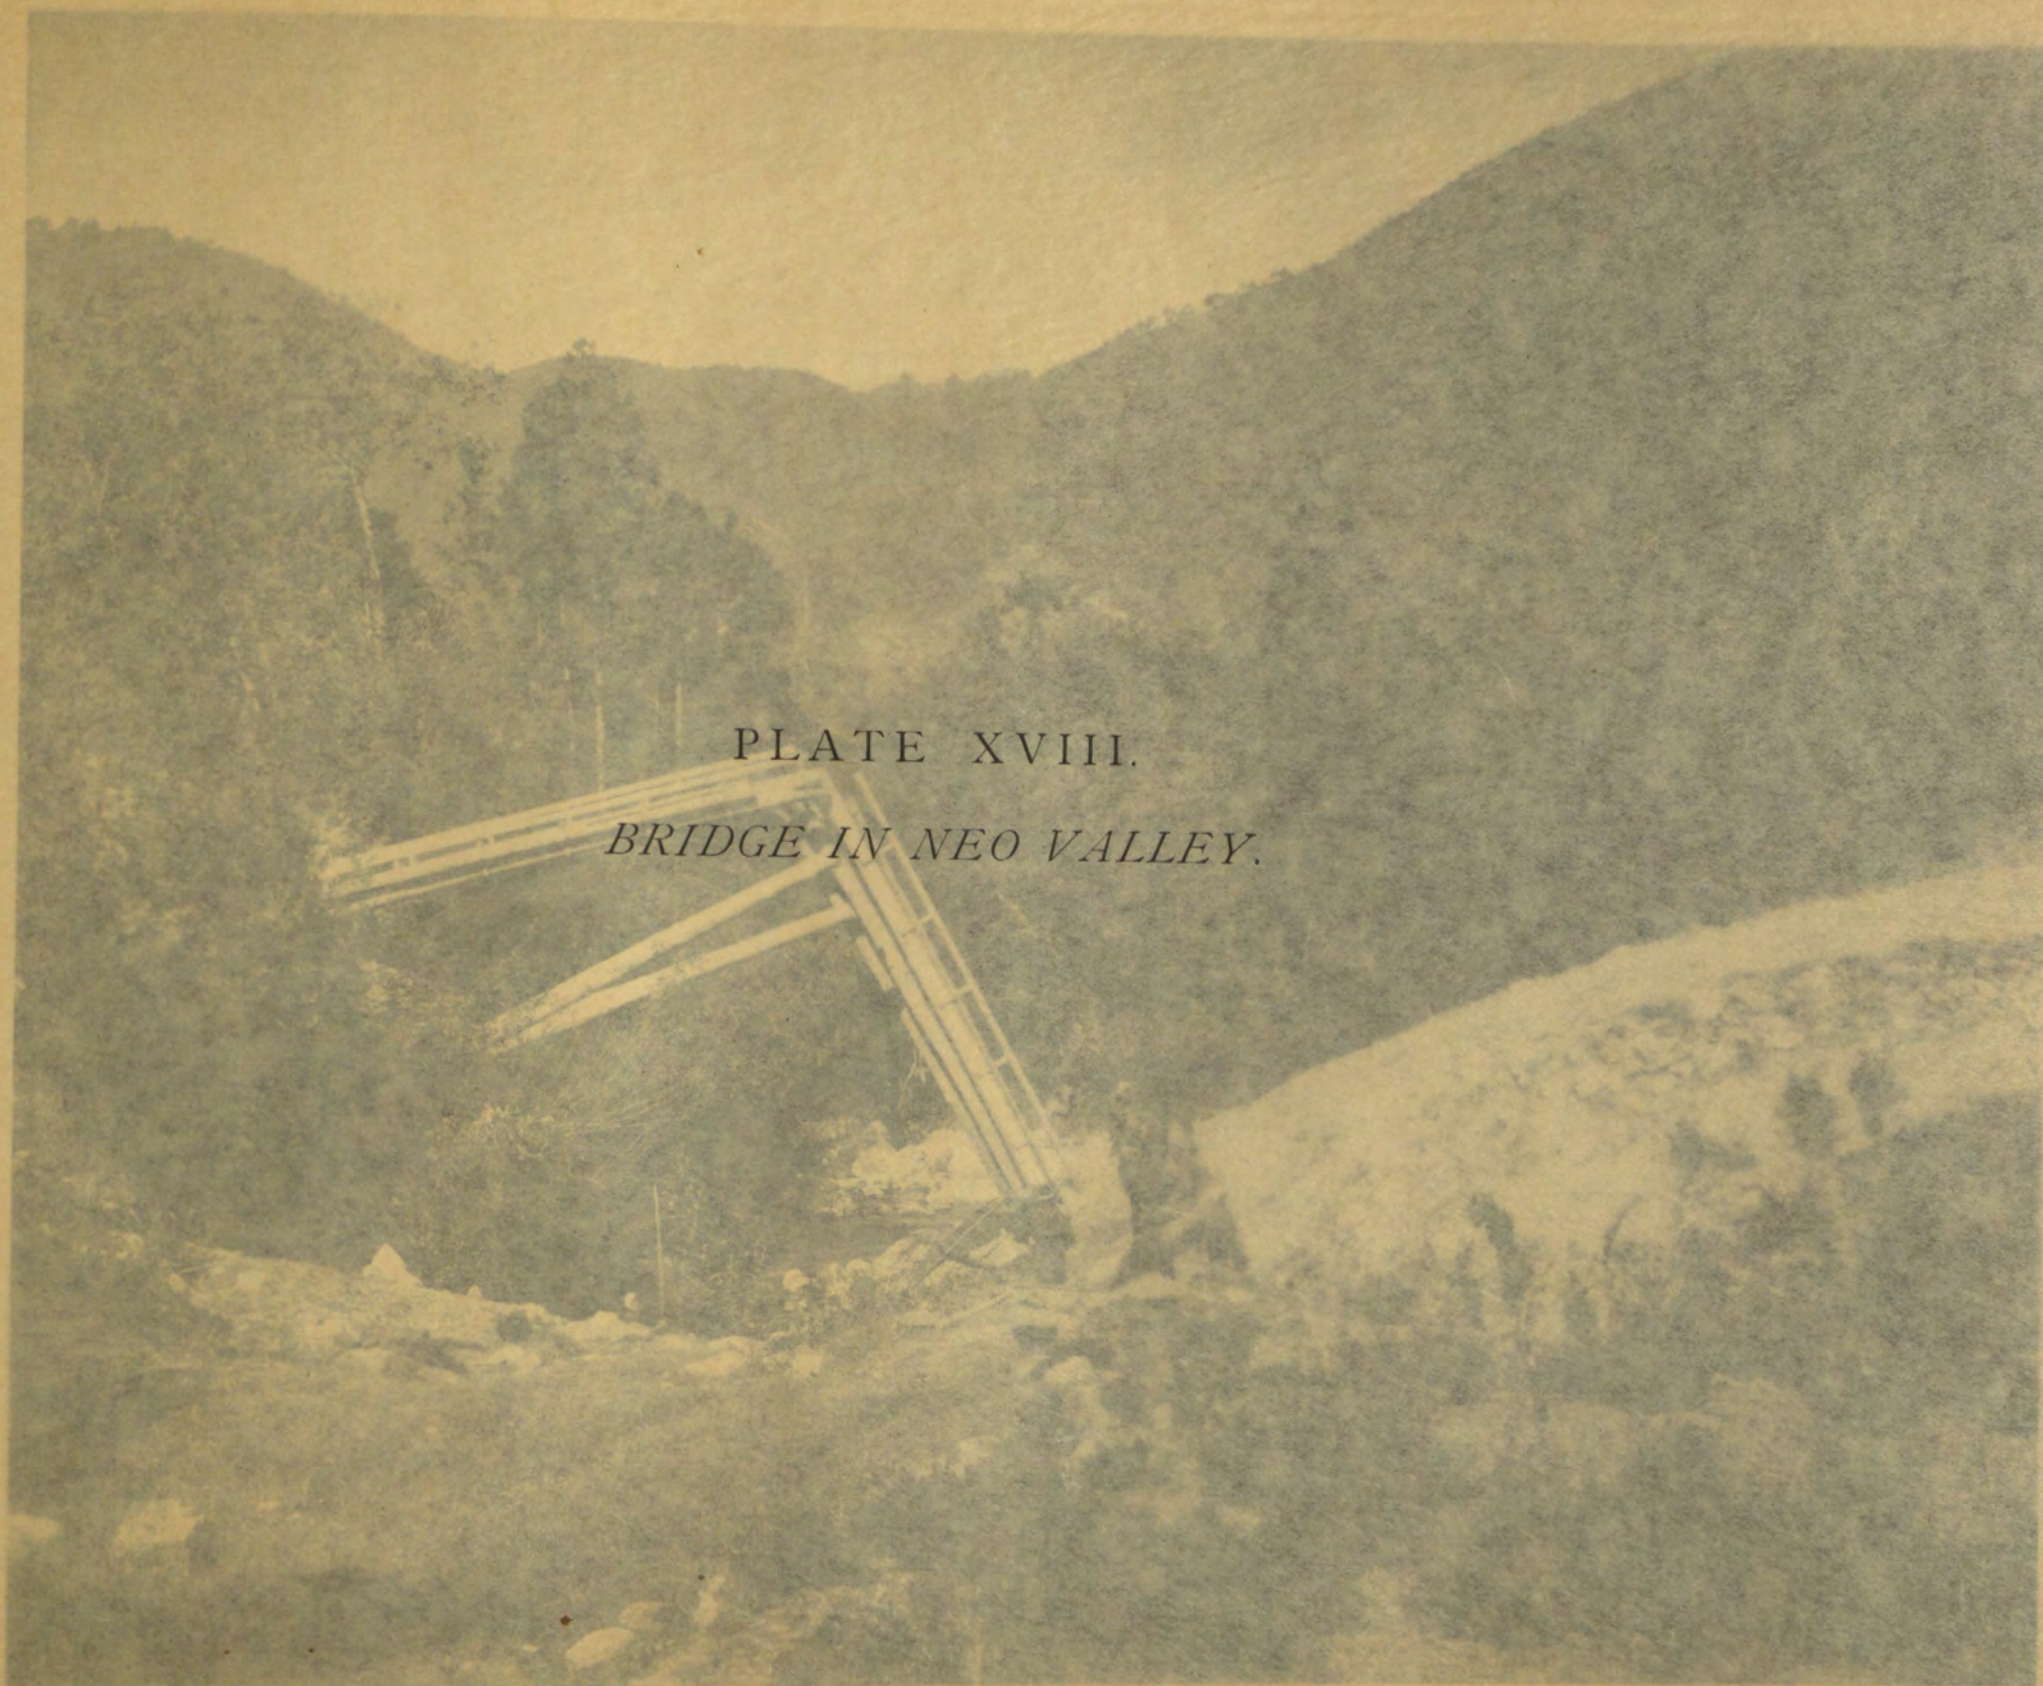
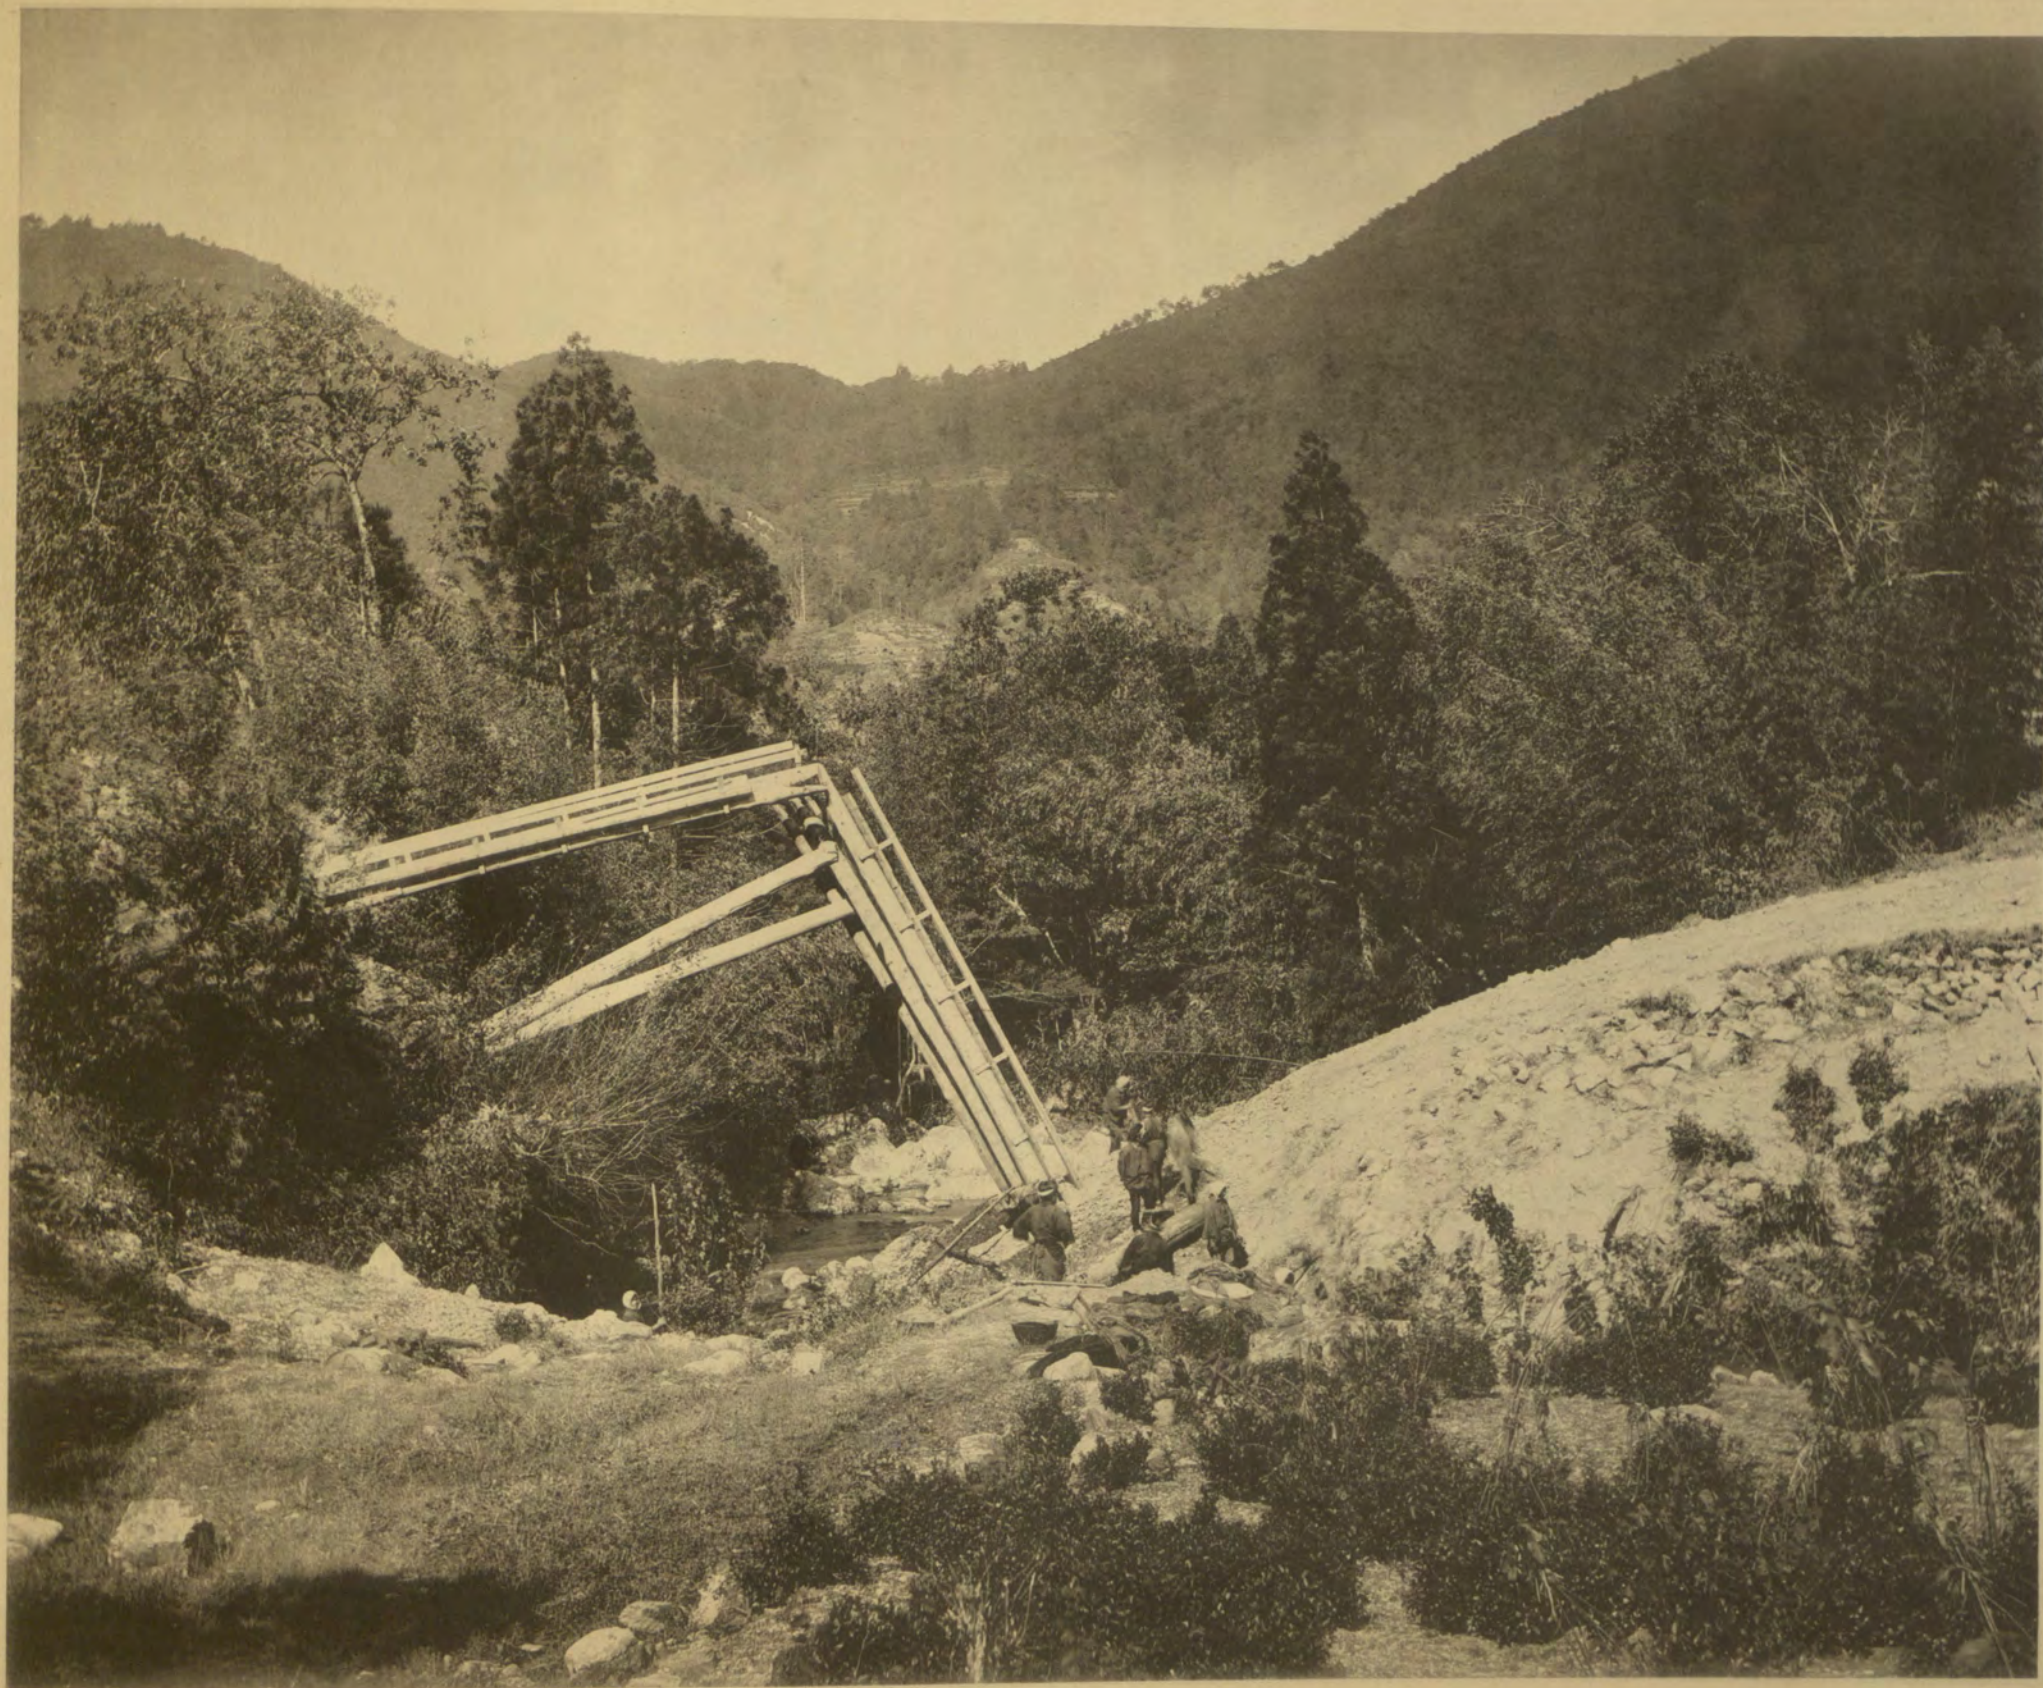
PLATE XVIII.

ERE we have a scene in the famous Neo Valley, where the disturbance was practically at its maximum. In some places the ground has sunk, and at others risen, and the people say that the mountains themselves have been depressed, so that from certain points hills formerly invisible now raise up their heads.

On the left of the picture a portion of a light cantilever bridge remains in position: The frame forming the middle span has fallen downwards, and two of its leg-like supports are seen nearly parallel with the cantilever. Restoring what was the horizontal portion of the bridge to its original position, we see that the second pair of supports, which must have occupied a position in front of the dark *Cryptomeria* standing amongst bamboo, in the background, and the right hand cantilever, have been swept away, the ground having either sunk, or been spread right and left by the violence of the shaking.

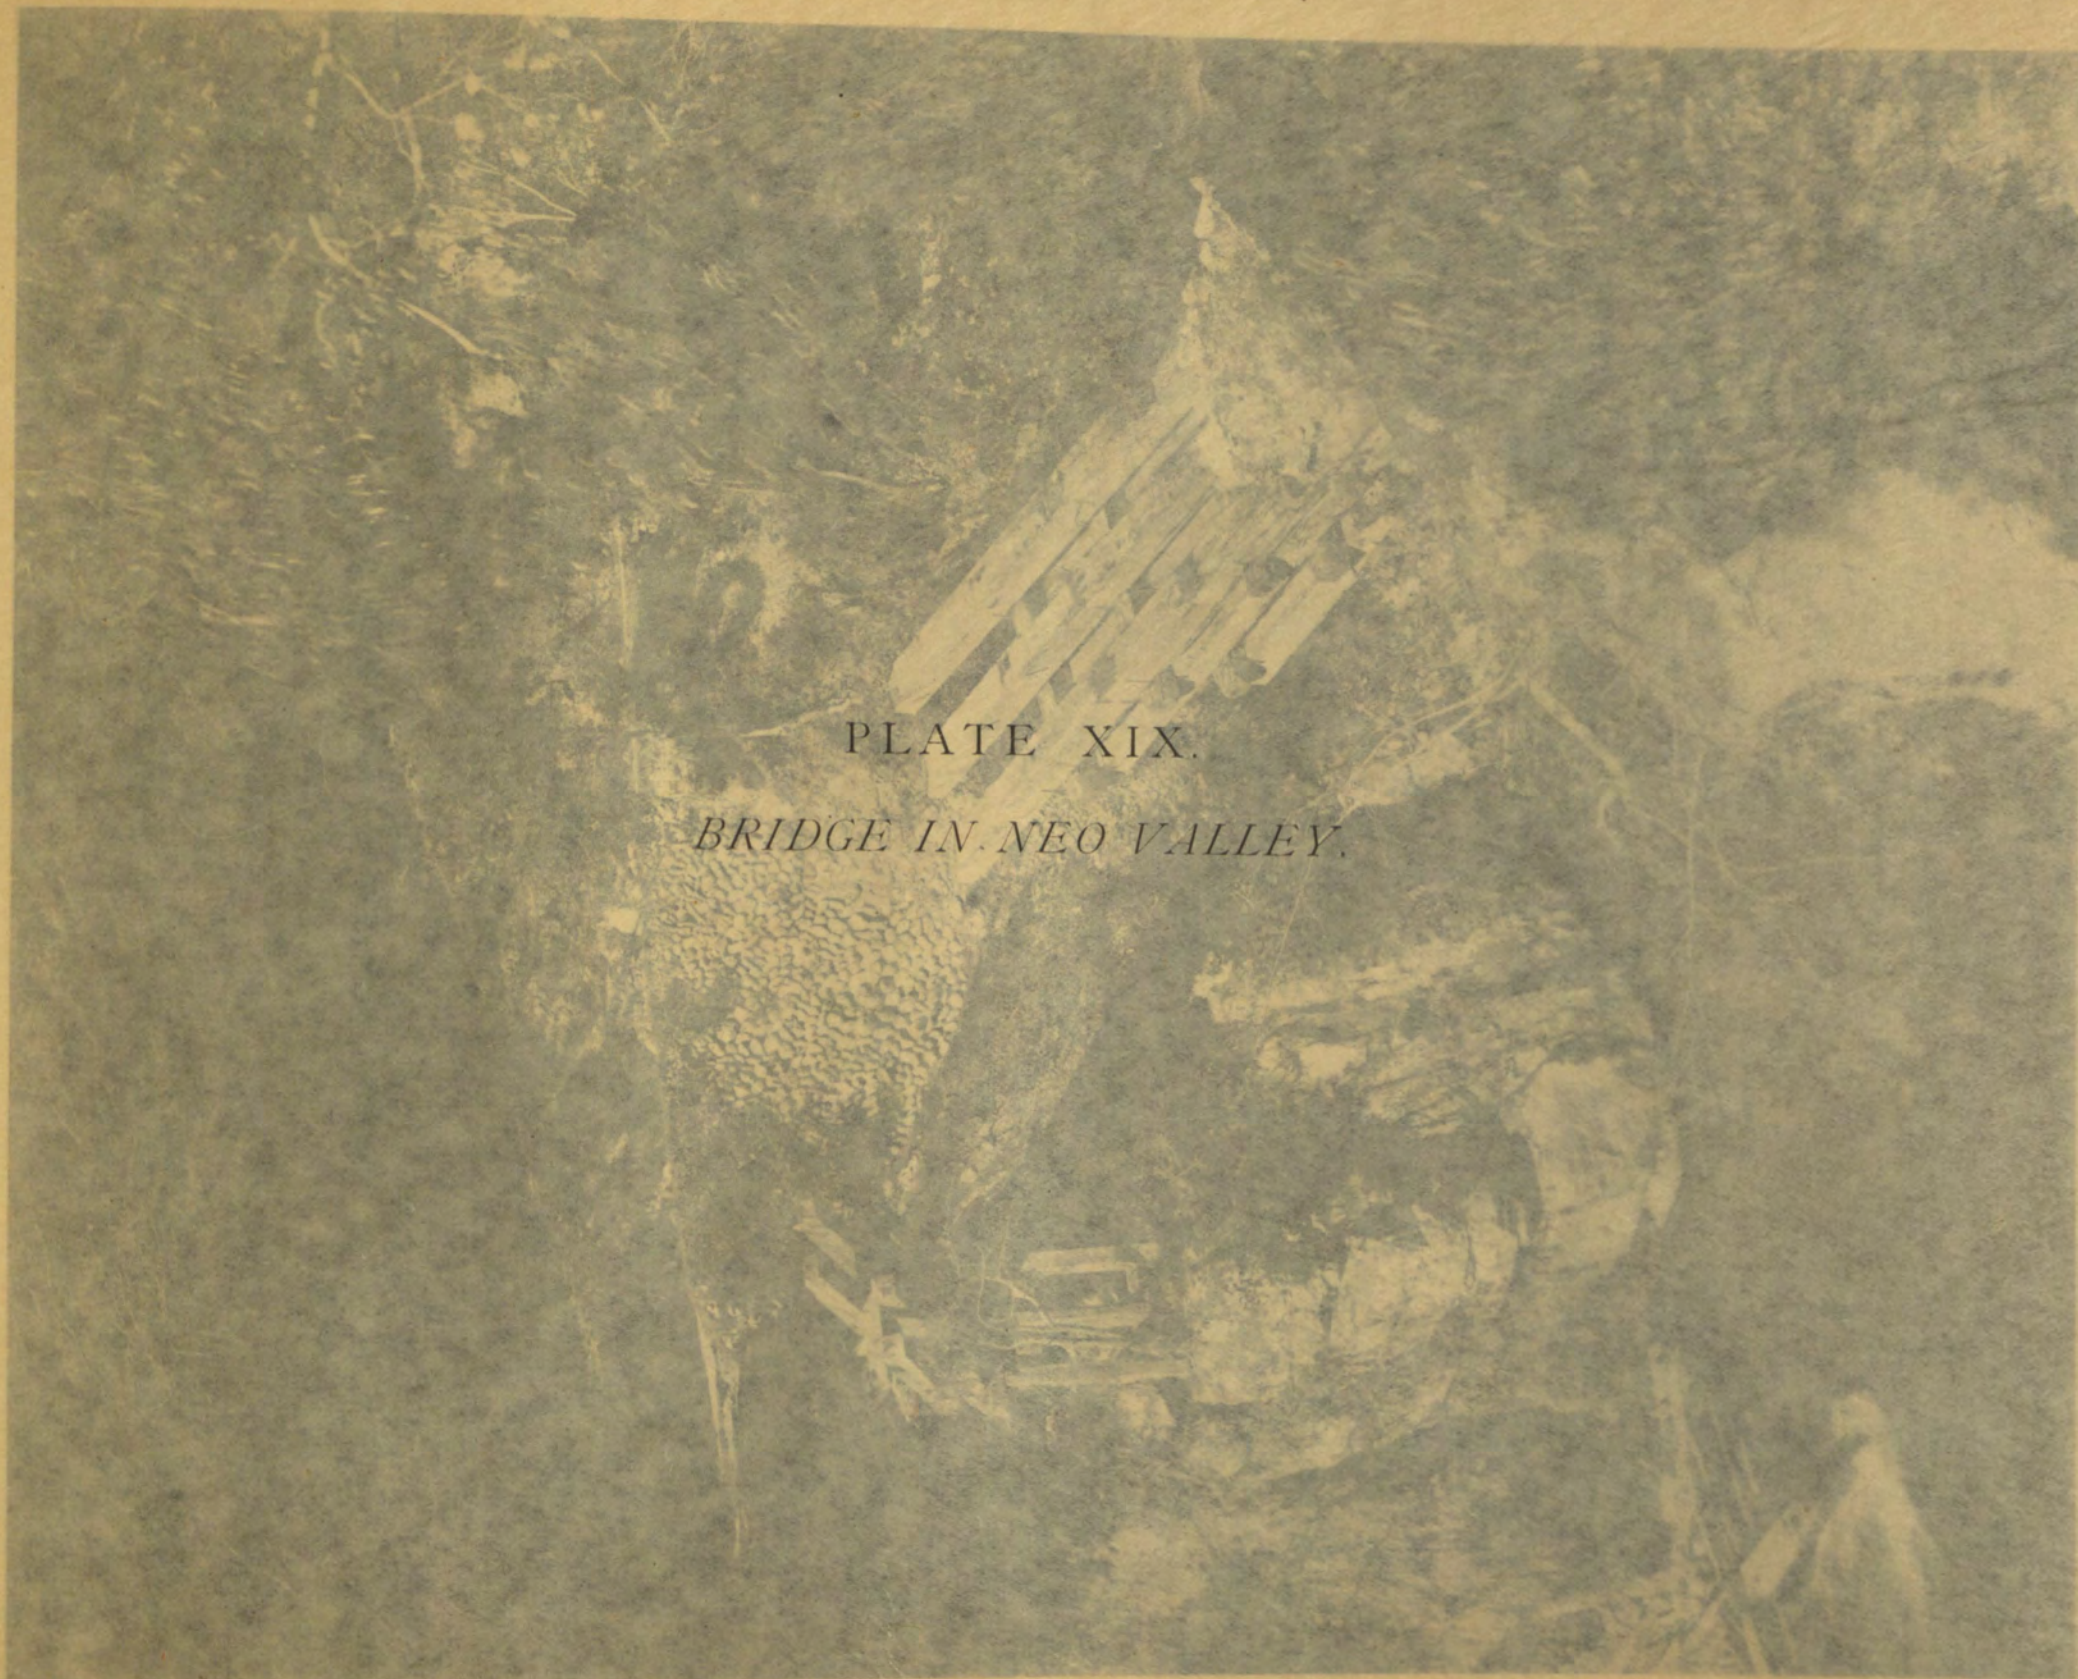
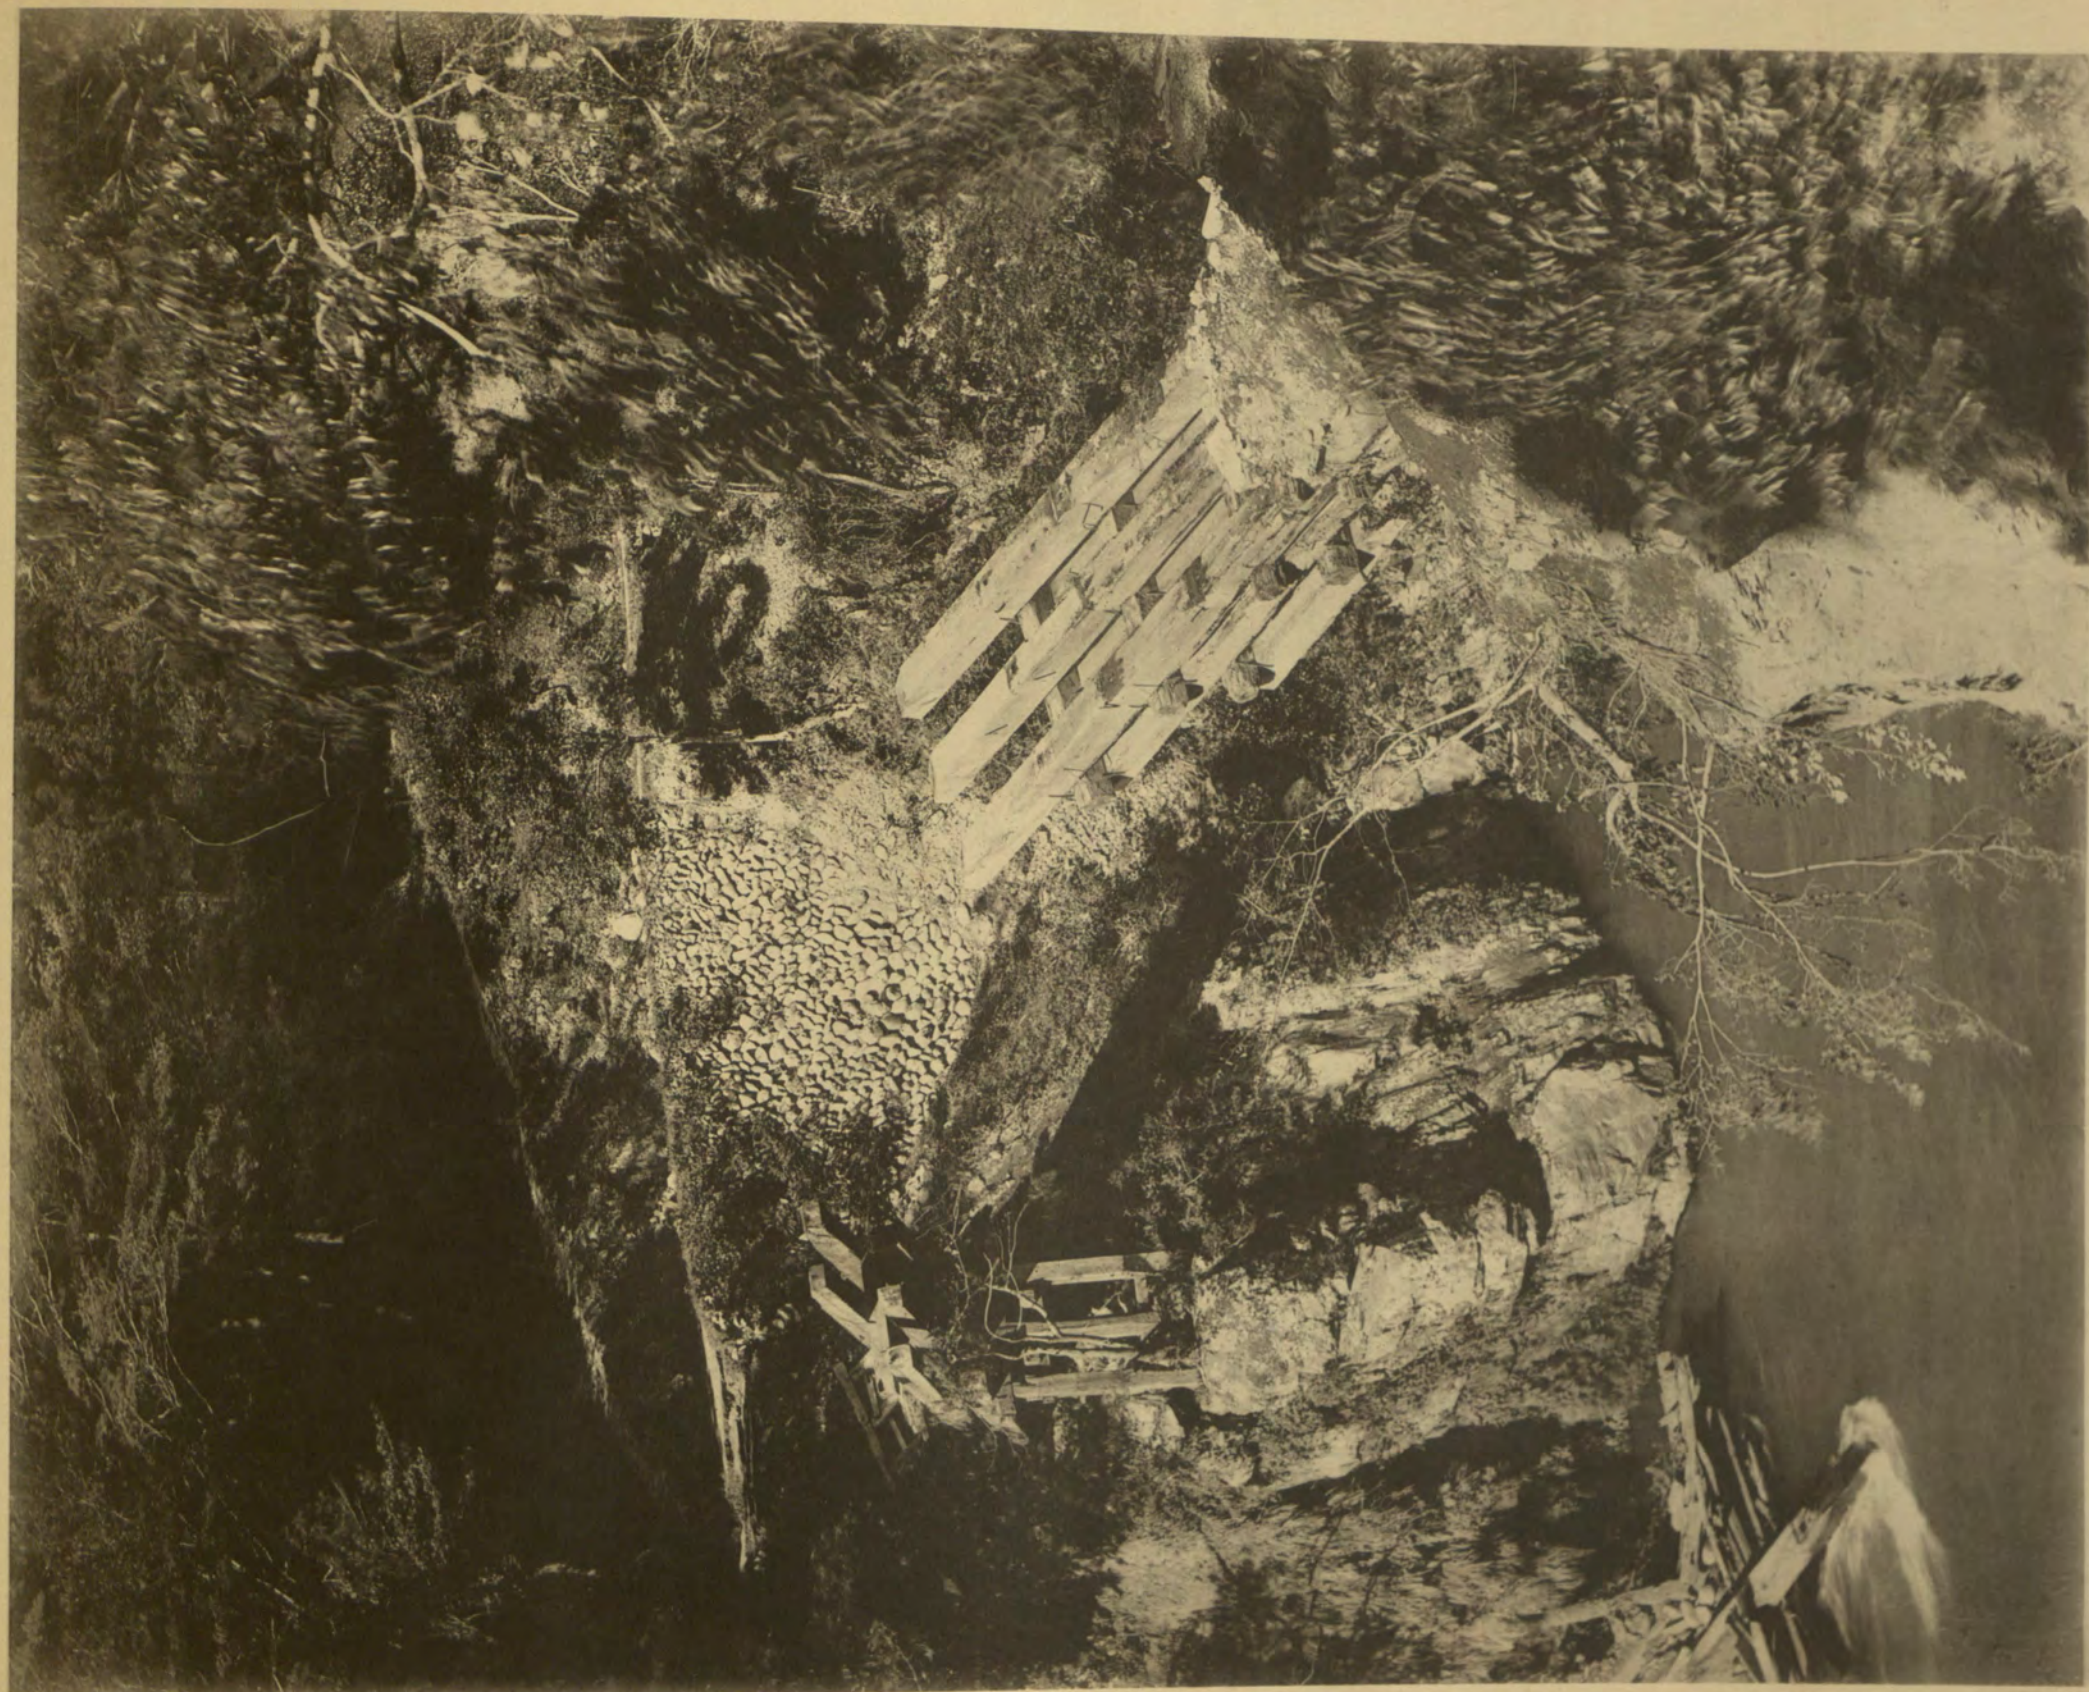
PLATE XIX.

BOUT five miles above Hinata we met with an unexpected obstacle. The river here had to be crossed but the centre of the cantilever bridge had been totally destroyed by the Earthquakes, and on account of the rain, the river was not fordable. One little bit of the central span is seen in the left hand corner of the picture. It is remarkable that the forces which had destroyed the bridge had failed to disintegrate the rubble wall supporting the pathway on the opposite bank of the stream.

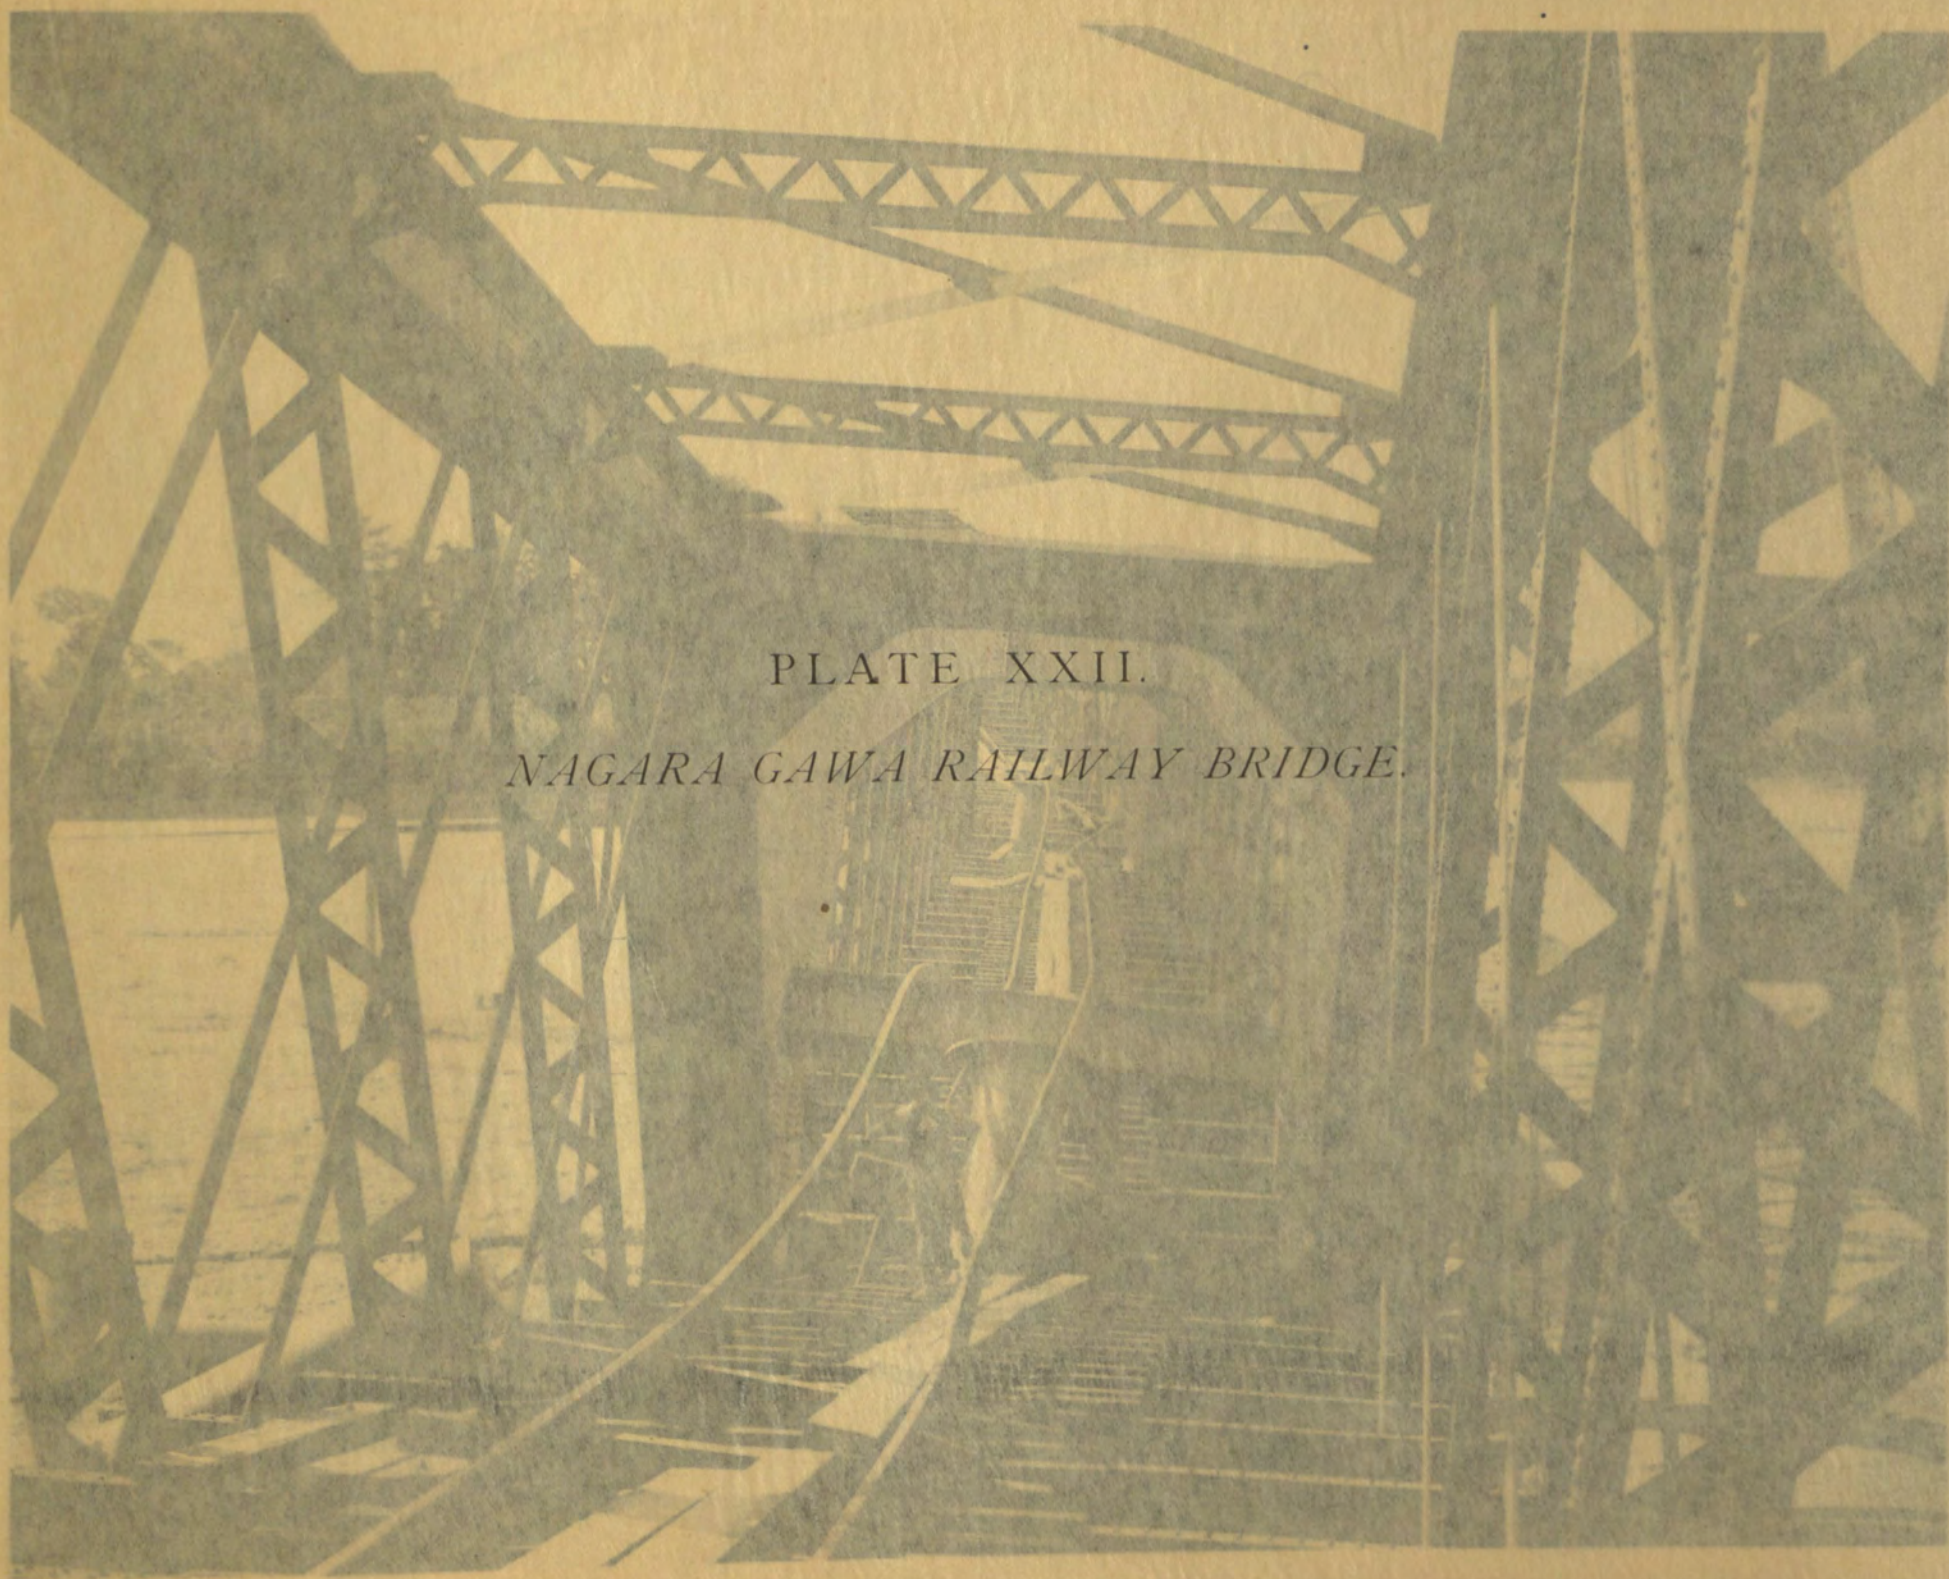
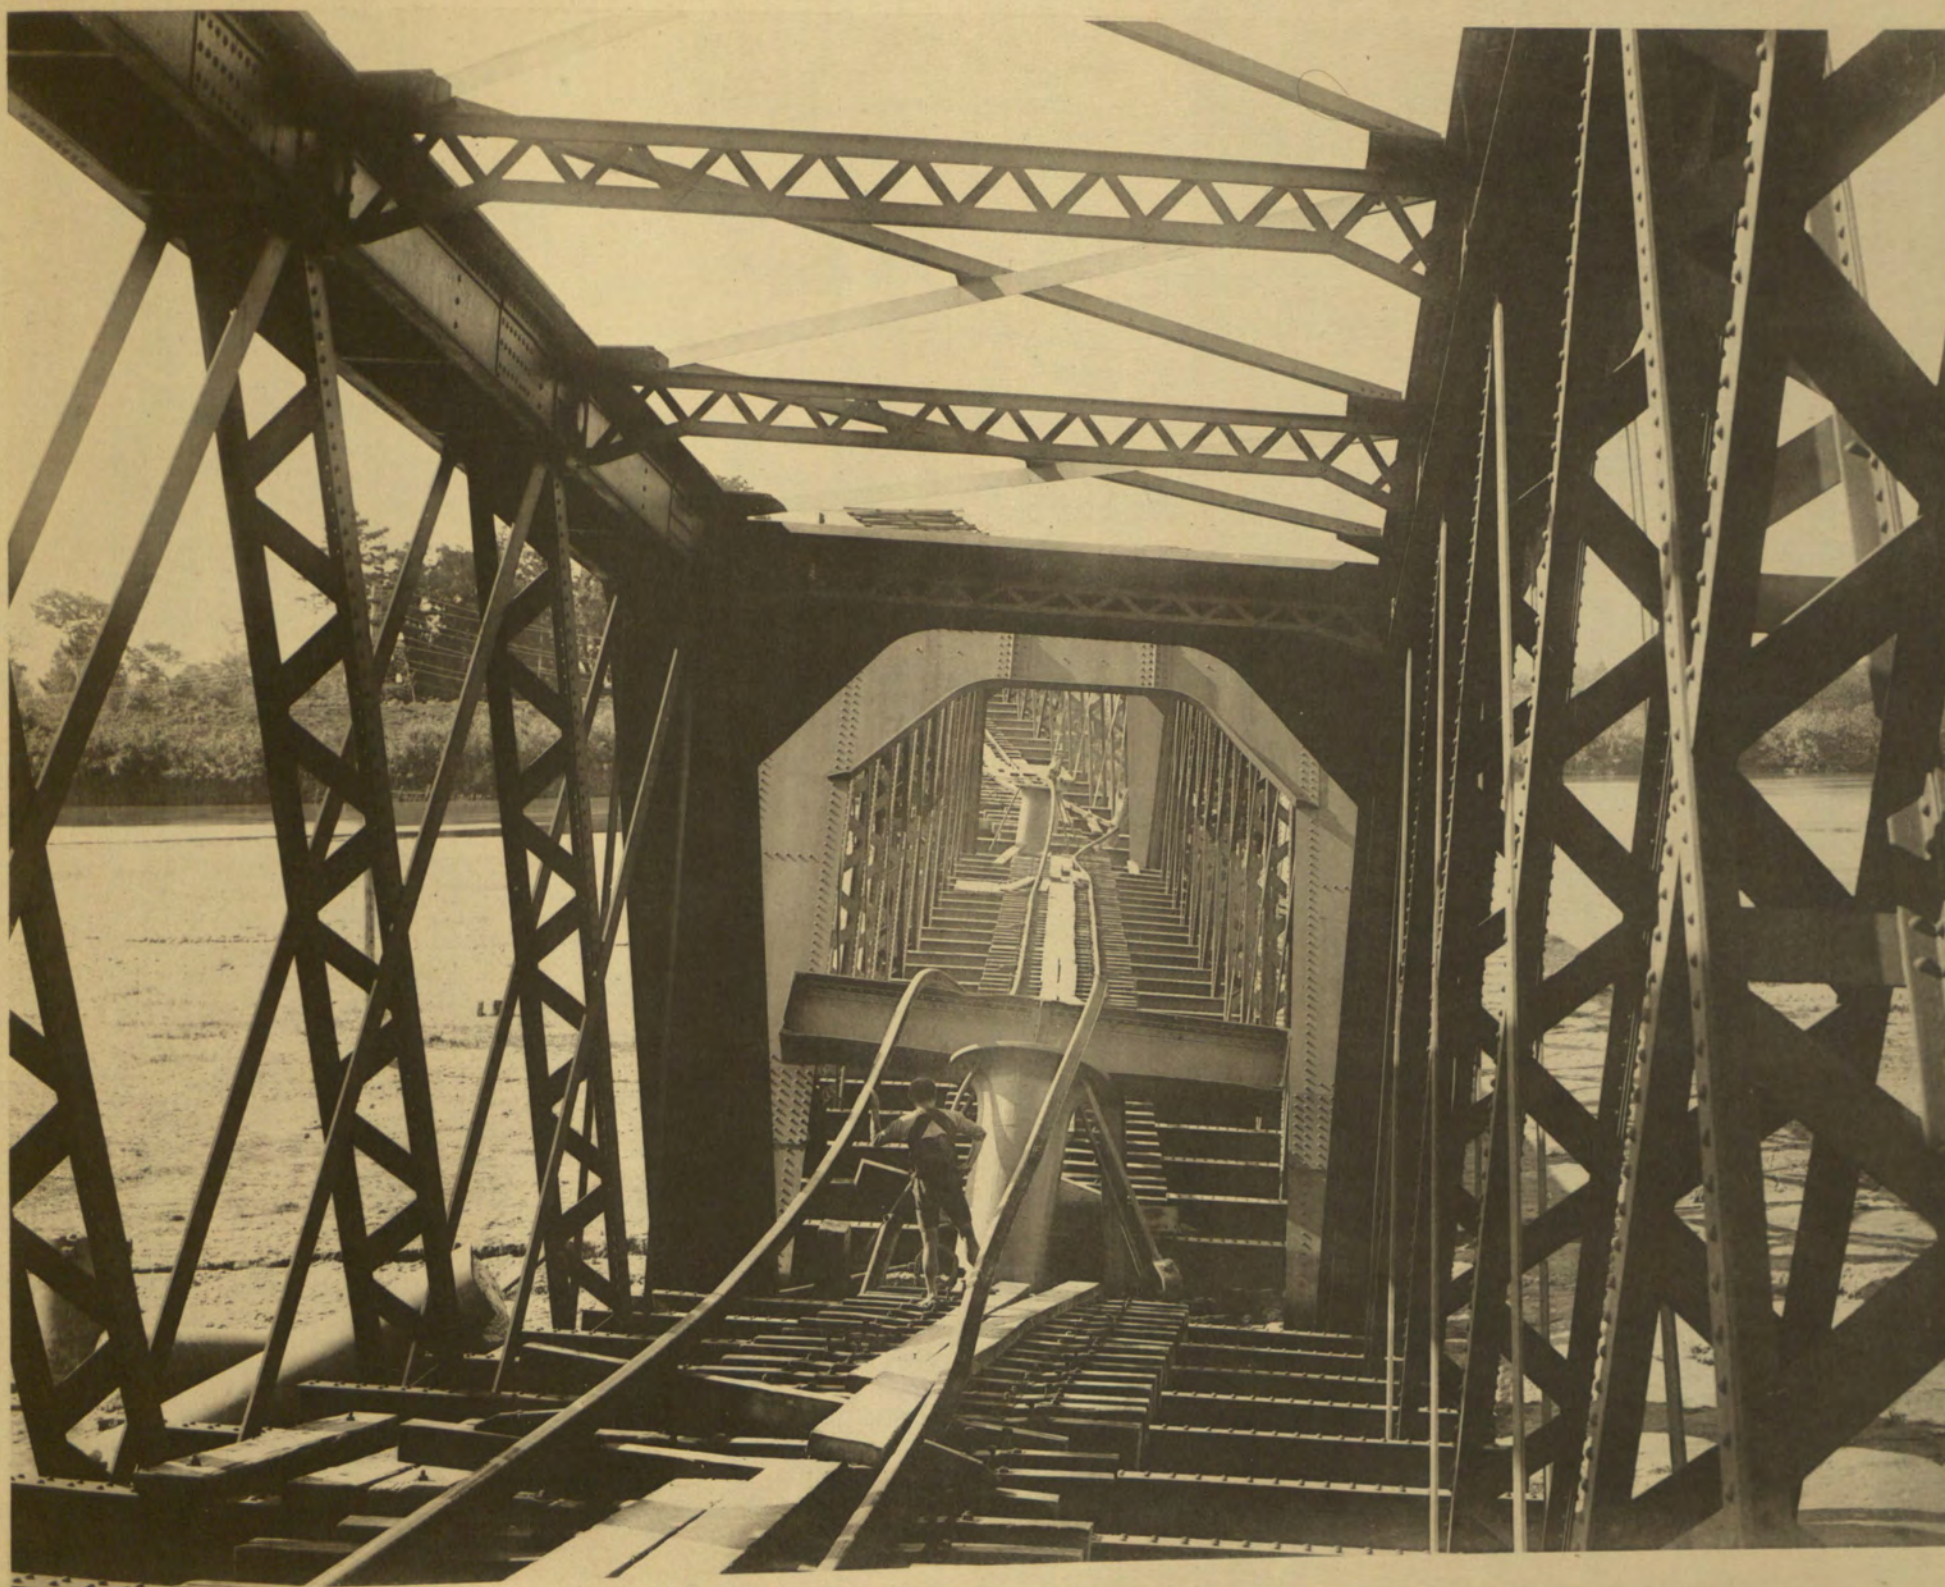
PLATE XXII.

N this picture we see the broken cast iron piers lying on the dry shingly bed of the river, like pieces of a huge carrot, and also that the original line of the bridge has, in its central part, been deflected up stream.

Although the cracks in the banks being parallel to the river, seem to indicate a movement, or the component of a movement, at right angles to their length, yet here, as at other bridges, it would appear that the movements, especially in the central parts of the river beds, have resulted in extensive permanent displacements, either up or down stream. Whether it is possible for engineers to build bridges which will resist such large bodily displacements as have been experienced along the bed of the Nagara and other rivers is a matter of question. Had the piers risen from a broader base, been made of wrought iron and had an Eifel tower like form, although they might not have been fractured, it is difficult to imagine that lateral shifting and bending would have been avoided.
